May 17, 2021

URGENT: FIELD SAFETY NOTICE – MMS-21-3999

T34™ Ambulatory Syringe Pumps
3rd Edition
Serial numbers: S00402878 and onwards
Type of Action: Field Work

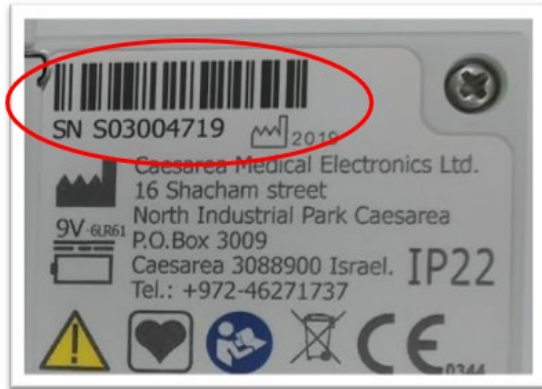
Appendix 1: Identification of the serial number on the reverse of T34™ Ambulatory Syringe Pumps

Serial numbers within the range S00402878 and onwards are in scope of this software upgrade and will be issued a new version of the Directions for Use (DFU) once upgraded. Please refer to Appendix 1 for guidance on identifying the serial number on your 3rd Edition T34™ Ambulatory Syringe Pump.
