URGENT – FIELD SAFETY NOTICE

Arjo Sara Plus lift – Risk of ignition

Date:	31 March 2022
Product Issue:	Risk of device ignition
Affected Product:	Sara Plus floor lifts
Resolution:	Product retrofit by Arjo service
Field Safety Notice:	FSN-POZ-001-2022
Pages:	5
Single registration number of manufacturer in EU:	SE-MF-000000696

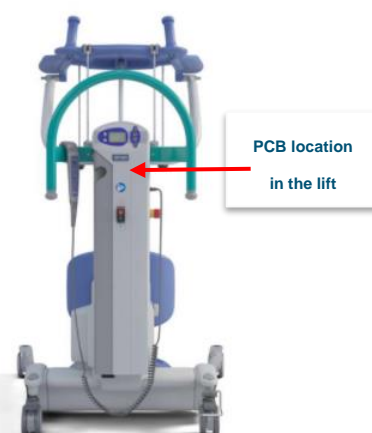
Our sales and service records indicate that you may be in possession of one or more Sara Plus lifts equipped with a PCB (Printed Circuit Board) that is prone to damage during product use. The PCB is an electronic part located inside the lift underneath the cover, as shown below.

Note: Affected devices are Arjo Sara Plus floor lifts manufactured from 13 October 2016 with the HMX1350-1 PCB, and Arjo Sara Plus floor lifts on which a PCB was replaced to HMX1350-1 after that date. Other Arjo lifts are unaffected with the risk of PCB damage.

It has been found that internal damage of the affected HMX1350-1 PCB may lead to overheating of the part and excessive heat emission which could potentially damage the PCB cover or, in the worst case, cause its ignition.

We will arrange a visit to your facility by an Arjo engineer to complete the Sara Plus correction with a service kit developed by the manufacturer to eliminate the issue.

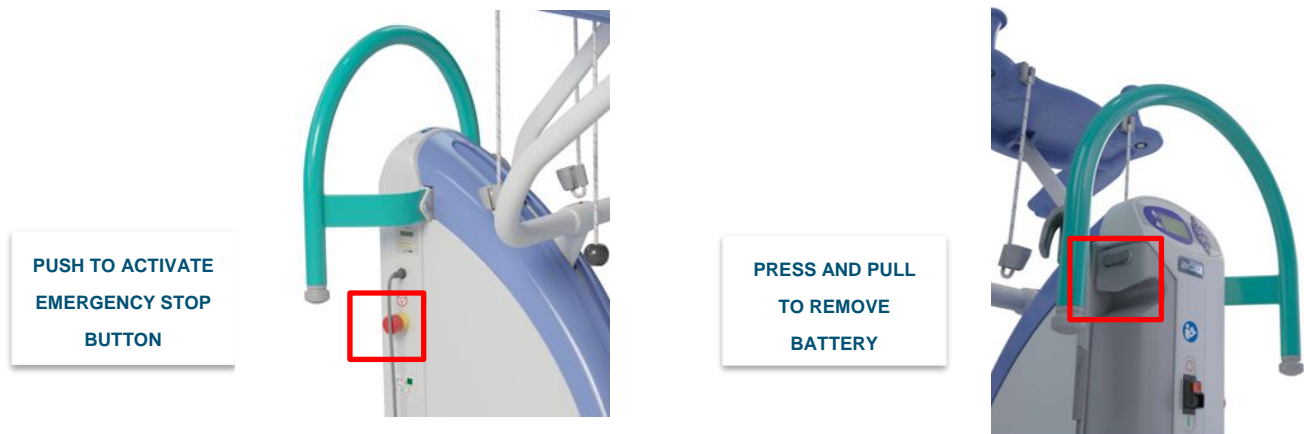
Before an ignition may occur, it can be preceded by white smoke coming out of the lift. The emitted smoke is not harmful and unlikely to result in any health consequences. **However, as soon as you notice any smoke, stop using your Sara Plus lift immediately – push the Emergency Stop Button and remove the battery from the battery socket to prevent from any further failure (please refer to an image below).**

Next, contact Arjo Service for further assistance. The smoke will phase out completely by itself after less than 3 minutes.
