Welch Allyn, Inc. 4341 State Street Road Skaneateles Falls, NY 13153 USA	URGENT: Field Safety Notice	FA-2021-05-001-SKF-004
---	------------------------------------	------------------------

Commercial name of affected product:
Braun® Thermoscan® Pro 6000 Ear Thermometer

Subject:
Potential risk of probe tip overheating

FSCA-identifier: FA-2021-05-001-SKF-004

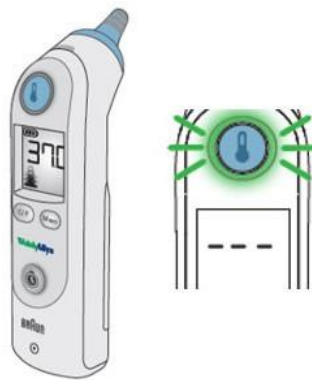
Figure 1

Our investigation has confirmed that the probe tip overheating is the result of fluid ingress. Fluid ingress causes the sensor to behave inconsistently, which does not allow the built-in safety mitigation (turn off the heating element) to work correctly. The majority of the devices which experience overheating of the probe tip show one of two behaviors at time of power up:

1. The ring around the measurement button will show a green blinking or flashing light instead of a ready state (solid green light).
2. The device requires multiple power-ups prior to going to ready state (solid green light). See Figure 1.

2. Do not use the device if the ring around the measurement button shows a green blinking or flashing light instead of a “ready state” (solid green light) and contact Hillrom Customer Service to report this issue.
3. Do not use the device if the device requires multiple power-ups prior to going to “ready state” (solid green light) and contact Hillrom Customer Service to report this issue.
4. If you experience an overheating probe tip, do not use the device and contact Hillrom Customer Service to report the issue.
5. Complete the attached response form and return to HillromSKF004OUS@stericycle.com within one month.
