Welch Allyn, Inc. 4341 State Street Road Skaneateles Falls, NY 13153 USA	URGENT: Field Safety Notice	FA-2021-05-001-SKF-004
---	------------------------------------	------------------------

Braun® Thermoscan® Pro 6000 Ear Thermometer

Potential risk of probe tip overheating

FSCA-identifier: FA-2021-05-001-SKF-004

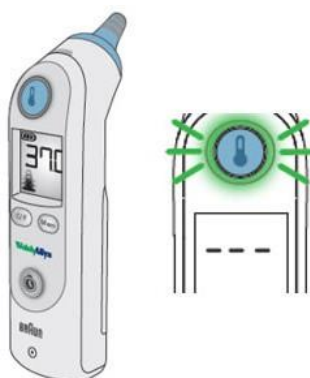
Figure 1

Our investigation has confirmed that the probe tip overheating is the result of fluid ingress. Fluid ingress causes the sensor to behave inconsistently, which does not allow the built-in safety mitigation (turn off the heating element) to work correctly. The majority of the devices which experience overheating of the probe tip show one of two behaviors at time of power up:

1. The ring around the measurement button will show a green blinking or flashing light instead of a ready state (solid green light).
2. The device requires multiple power-ups prior to going to ready state (solid green light). See Figure 1.

2. Do not use the device if the ring around the measurement button shows a green blinking or flashing light instead of a “ready state” (solid green light) and contact Hillrom Customer Service to report this issue.
3. Do not use the device if the device requires multiple power-ups prior to going to “ready state” (solid green light) and contact Hillrom Customer Service to report this issue.
4. If you experience an overheating probe tip, do not use the device and contact Hillrom Customer Service to report the issue.
5. Complete the attached response form and return to HillromSKF004OUS@stericycle.com within one month.
