<b>URGENT: VOLUNTARY FIELD SAFETY NOTICE</b>	
<b>Description</b>	<b>Handling guidance for specific catalog numbers of Alcon Phaco Tips when used with included plastic wrench</b>
<b>Relevant Product</b>	<b>Alcon Phaco Tips</b> (see Attachment 1)
<b>Alcon Record ID</b>	<b>2023.011</b>

5<sup>th</sup> July 2023

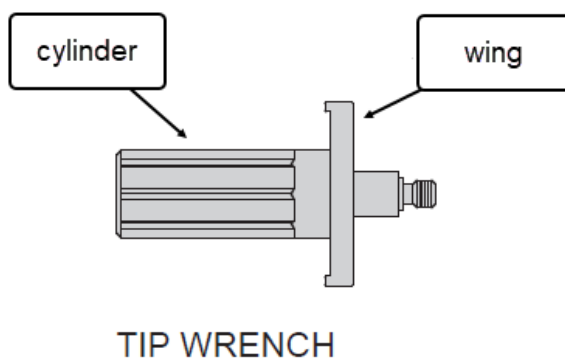
Alcon has become aware of the potential for the Phaco Tip wrench to generate plastic shaving particles if the Phaco Tip is over-tightened to the handpiece to the point where the wrench slips over the tip-to-wrench interface.

- A. In order to mitigate the potential for the wrench to be damaged by overtightening the Phaco Tip and associated generation of plastic particles, Alcon is advising customers of the following precautions:
  - To fasten the tip into the handpiece, grasp the plastic wrench by the cylindrical part of the wrench. Overtightening by leveraging the wings can increase the likelihood that the wrench may slip over the tip-to-wrench interface, causing damage to the wrench, and has the potential to generate plastic particles which may remain on the exterior of the Phaco Tip and/or distal end of the phaco handpiece.
