URGENT Field Safety Notice

Trilogy Evo, Trilogy Evo O2, Trilogy EV300
Loss of Power Alarm

26-FEB-2024

Reference: TrilogY Evo Battery Failure Alarm
TrilogY Evo, TrilogY Evo O2, and TrilogY EV300
2024-CC-SRC-001

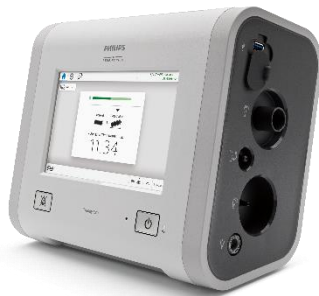
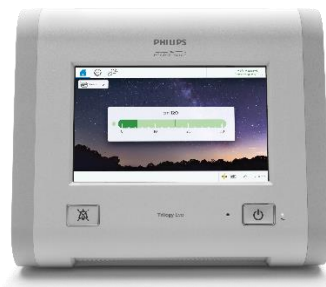
3. Affected products and how to identify them

All Trilogy Evo, Trilogy Evo O2, and Trilogy EV300 devices are susceptible to this problem.
