URGENT Field Safety Notice

Trilogy Evo, Trilogy Evo O2, Trilogy EV300
Flow Sensor Nebulized Aerosol Deposition

19-SEPT-2024

Reference: Flow Sensor Nebulized Aerosol Deposition
Trilogy Evo, Trilogy Evo O2, and Trilogy EV300
2024-CC-SRC-013

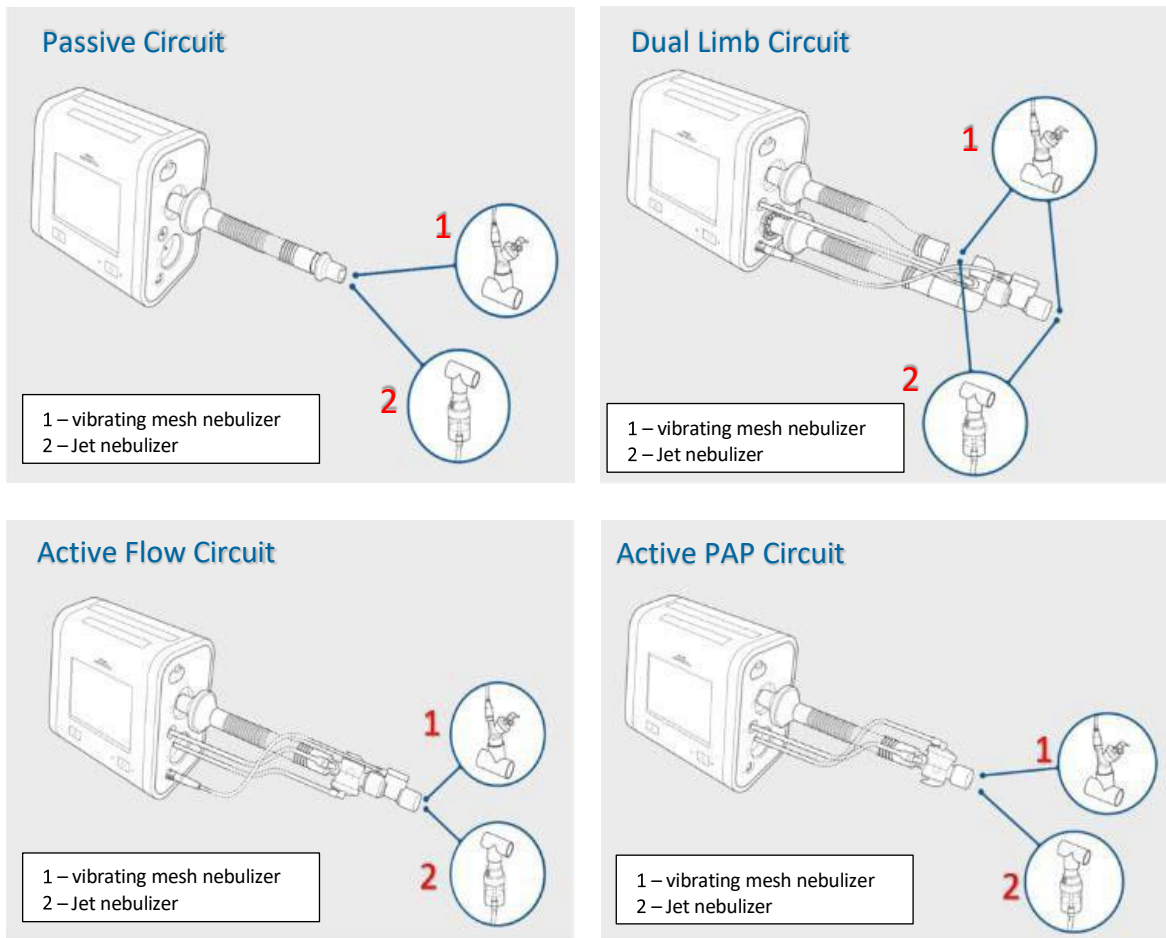
Figure 1: Acceptable In-Line Nebulizer Placement.

- When the in-line nebulizer is used with passive circuits for tidal volumes greater than or equal to 700 mL, or
- When the in-line nebulizer is placed at the dry side of the heated humidifier, or
- When the in-line nebulizer is placed at the “inspiratory port (to patient)” (device outlet), or
- When the in-line nebulizer is placed in any location *other than* those identified in the images in Section 4

- If using in-line nebulizer treatments:
 - The circuit must be configured as pictured in the images in **Figure 1** below
 - For prescriptions needing tidal volumes greater than 700 mL with a passive circuit, transition patient to alternate circuit (Active PAP, Active Flow, or Dual Limb).
