UPDATED: URGENT Field Safety Notice

Trilogy Evo, Trilogy Evo O2, Trilogy EV300
Flow Sensor Nebulized Aerosol Deposition

21-NOV-2024

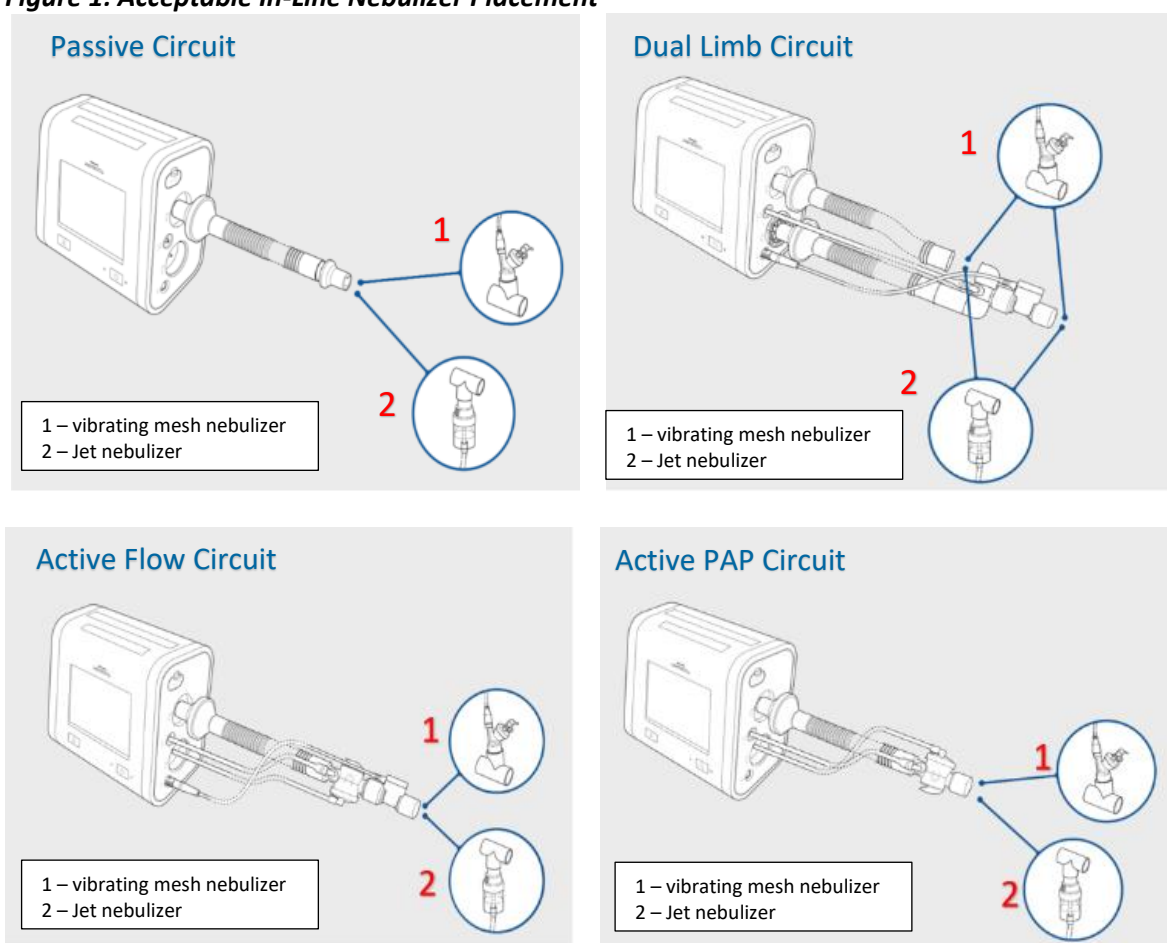
Figure 1: Acceptable In-Line Nebulizer Placement

- If using in-line nebulizer treatments:
 - The circuit must be configured as pictured in the images in **Figure 1** below.
 - For prescriptions needing tidal volumes greater than 700 mL with a passive circuit, transition patient to alternate circuit (Active PAP, Active Flow, or Dual Limb).

- When tidal volumes greater than 700 mL are used with a passive circuit, nebulized aerosol deposition can occur even if the nebulizer is placed as pictured.

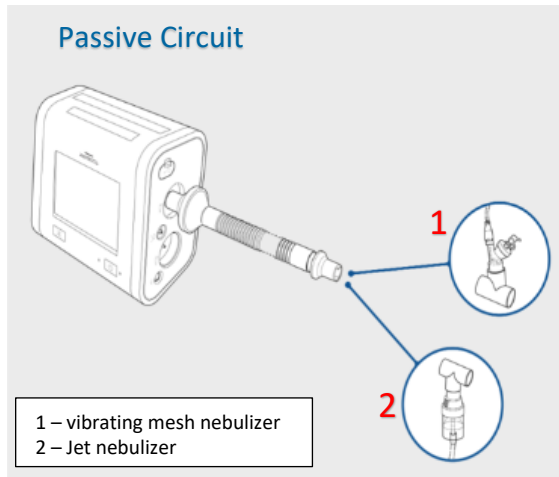
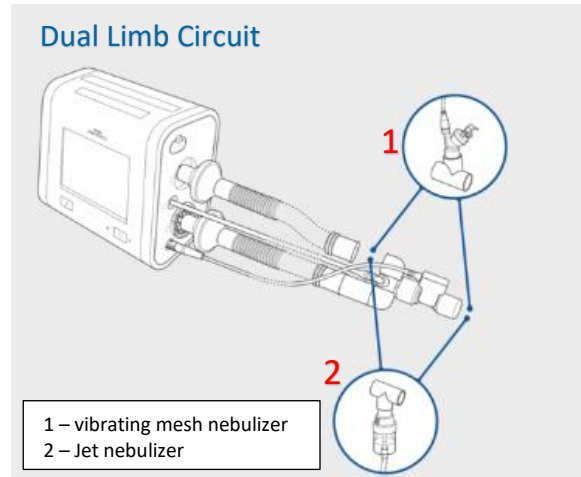
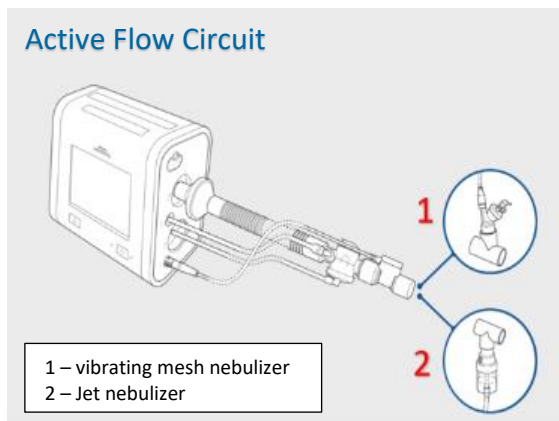
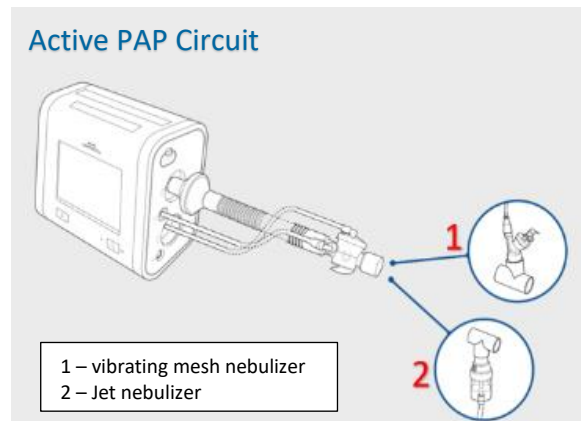
Appropriate Circuit Configurations for Use With In-Line Nebulizers

If using in-line nebulizer treatments, ensure the circuit is configured as shown in the images below.

Note: For prescriptions needing tidal volumes greater than 700 mL with a passive circuit, transition patient to alternate circuit (Active PAP, Active Flow, or Dual Limb).

- When tidal volumes greater than 700 mL are used with a passive circuit, nebulized aerosol deposition can occur even if the nebulizer is placed as pictured.
