11th March 2025

URGENT: FIELD SAFETY NOTICE – MDS-24-5154-B

4Fr Single Lumen PowerPICC (SOLO and non-SOLO versions)

Type of Action: Product Removal

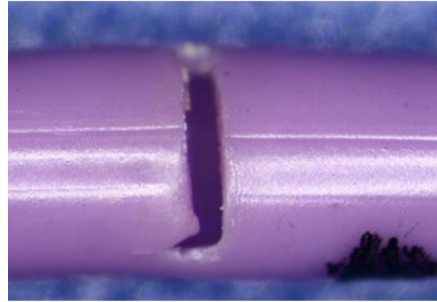
In October 2024, BD issued an advisory Field Safety Notice for unexpired lot numbers of 4Fr Single-Lumen PowerPICC Catheters (SOLO and non-SOLO versions) to inform customers about an observed increase of material fatigue leaks (Figure 1) on the 4Fr Single Lumen PowerPICC catheters in specific geographies.

BD has conducted a comprehensive investigation and has identified that three lots of resin used to extrude the tubing material exceeded our supplier's specification for a material property called Melt Flow Index (MFI). BD's investigation has shown that higher MFI could lead to increased material fatigue leaks. All of the extruded catheters meet BD specifications for dimensions and mechanical properties; however, BD is removing all product from the field that was extruded from resin that exceeded the supplier specification.

Figure 1: Example of transverse/circumferential crack in the catheter body

BD is now conducting a Field Safety Corrective Action to remove specific lots of **4Fr Single-Lumen PowerPICC Catheters** listed in Appendix 1.

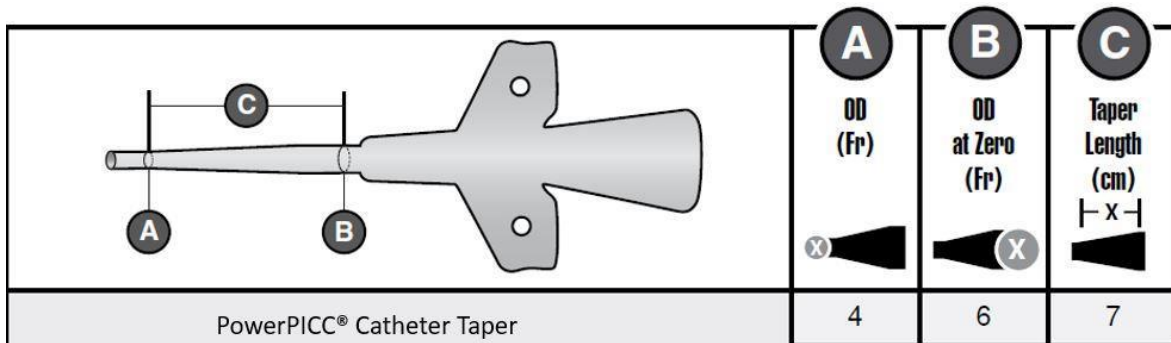
BD PICCs have a reverse taper which increases in diameter near the 0 marking on the device.

- Fully inserting the PICC device into the patient, as close as possible to the zero mark (position B in Figure 2), including the kink-resistant, reverse tapered region at the insertion site, is associated with lower leakage rates. To determine corresponding compression style size see figure 2, which shows that for the 4 Fr PICC, the size will be between 4 to 6 Fr, depending on the position of the securement device relative to the taper.

Figure 2: Image of the PowerPICC Taper Region

- BD strongly recommends the use of adhesive backed securement systems (e.g. Statlock) instead of 'compression style' securement systems.
- Securement systems should be appropriately sized to accommodate the increase in diameter of the catheter in the taper region.

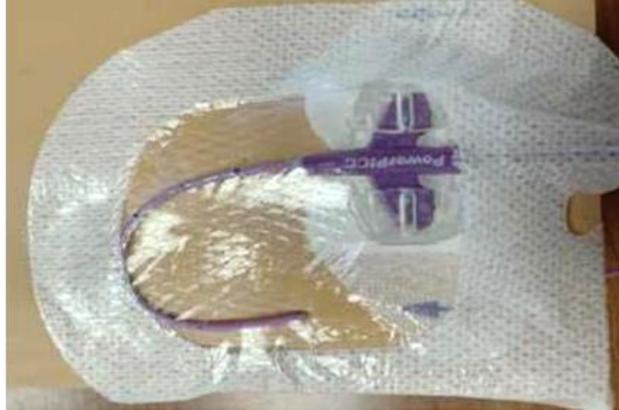
- Please note, using the J-loop technique when placing or dressing the catheter prevents insertion to the 0 mark and the use of this kink-resistant, reverse tapered region at the insertion site. See Figure 3 for an image of the J-loop. Where possible, refrain from using this technique.

Figure 3: Image of the J-loop
