URGENT: FIELD SAFETY NOTICE – MDS-24-5154-C

4Fr Single Lumen PowerPICC (SOLO and non-SOLO versions)

Type of Action: Product Removal

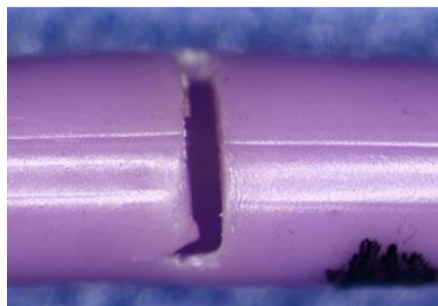
In March 2025, BD issued a global product removal due to an increase of material fatigue leaks on **4Fr single-lumen PowerPICC catheters**, both SOLO and non-SOLO versions, in specific geographies. These leaks are primarily characterised by a transverse/circumferential crack in the catheter tubing (Figure 1).

Figure 1: Example of transverse/circumferential crack in the catheter tubing

- The resin used to extrude the catheter tubing exceeded our supplier's specification for a material property called melt flow index (MFI). BD's investigation has concluded that a higher MFI could make the PowerPICC catheter tubing more susceptible to leakage when placed under stress.

- Insertion and securement techniques that contradict the PowerPICC IFU requirements, such as the requirement to insert the catheter as close to the zero mark as possible.

- BD has implemented additional controls around MFI that provides increased level of product assurance.

- BD is removing additional unexpired lots of 4Fr Single Lumen PowerPICC, both SOLO and non-SOLO versions as described in Attachment 1.
- BD is notifying users to ensure practice is consistent with BD Instructions for Use (IFU) for insertion depth and securement.
- BD will provide product replacement or credit for all destroyed products.

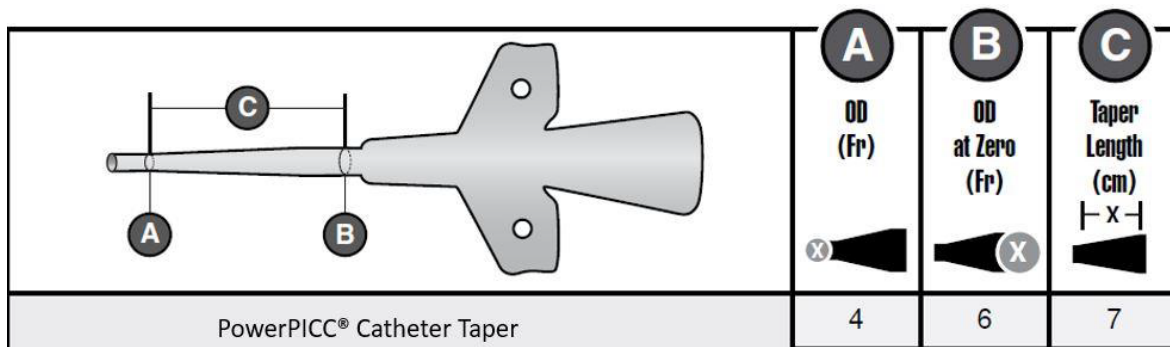
- BD PICCs have a taper design that increases in diameter near the zero-centimeter mark on the device.
 - When using any BD PICC, ensure practice is consistent with BD IFUs for insertion depth and securement, including insertion to the zero mark. Fully insert the PICC as close as possible to the zero-centimeter mark (position B in Figure 2). This allows the kink-resistant, tapered region to be utilised and is associated with lower catheter leakage rates.

Figure 2: Image of the PowerPICC Taper Region

- Select securement devices that can be used consistent with the BD PICC IFU.
