URGENT FIELD SAFETY NOTICE

RE: THUNDERBEAT Type S Hand Instruments

Olympus reference: QIL FY25-EMEA-26-FY25-009- Thunderbeat Jaw Breakage Issue

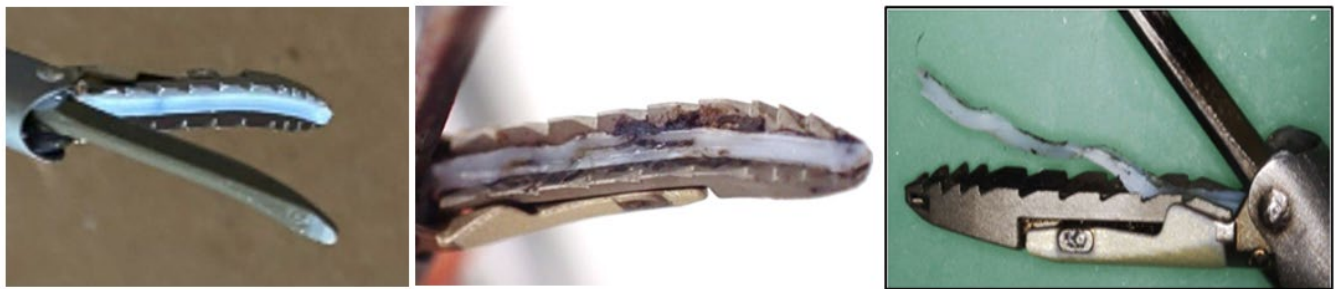
Olympus has been made aware, via customer feedback, of reports where probe tips of the THUNDERBEAT Type S Hand instrument are becoming damaged or are breaking (Reference example in Figure 1), as well as instances of pad damage or detachment (Reference example in Figure 2). These issues can occur when the instructions and warnings in the IFU are not followed, specifically, taking very large bites of tissue, contact with metal while activating, and activation without tissue between the jaws.

Figure 2. Example of Thunderbeat Probe in accordance with specifications (Left), Tissue Pad Deformation (Center), Tissue Pad Detachment (Right)

A broken probe tip or damaged tissue pad may lead to patient harms of foreign body in the patient, requiring imaging and prolonged operative time or an additional procedure to locate and remove the broken piece. Additionally, tissue damage and bleeding could occur due to exposed sharp edges. A broken piece remaining in the patient could potentially lead to an inflammatory reaction or granuloma. The probe tip or tissue pad breaking due to high temperatures and falling into the patient, may cause thermal injury to the patient.

In addition, Olympus strongly recommends the use of the ITM (Intelligent Tissue Monitoring) function to prevent probe pad damage due to over-activation, and therefore reduce the likelihood of probe tip damage. When using this function, the energy output automatically stops after the target tissue is divided. This is indicated by an audible signal/stop tone. Note: This function may need to be switched to 'on' on your generator, if not already enabled.

1. Carefully read the content of this FSN.
2. Ensure all personnel are completely knowledgeable and thoroughly trained on the content of this FSN and the relevant IFU.
3. If you have further distributed this product, identify your customers, and forward this FSN to them
4. Olympus requests that you acknowledge receipt of this FSN, by:
 - a. Indicating on the enclosed Reply Form if you would like to receive in-service training to support the correct use of this device.
 - b. Demonstrating that you have received and understood this notification by completing all available fields in the Reply Form and returning it back to your local Olympus representative; ra@olympus.co.uk latest by 20 January 2025.
