Olympus reference: QIL FY26-EMEA-17-FY25-009-A Thunderbeat Probe Fracture and Tissue Pad Detachment

URGENT FIELD SAFETY NOTICE

RE: THUNDERBEAT™ Hand Instrument

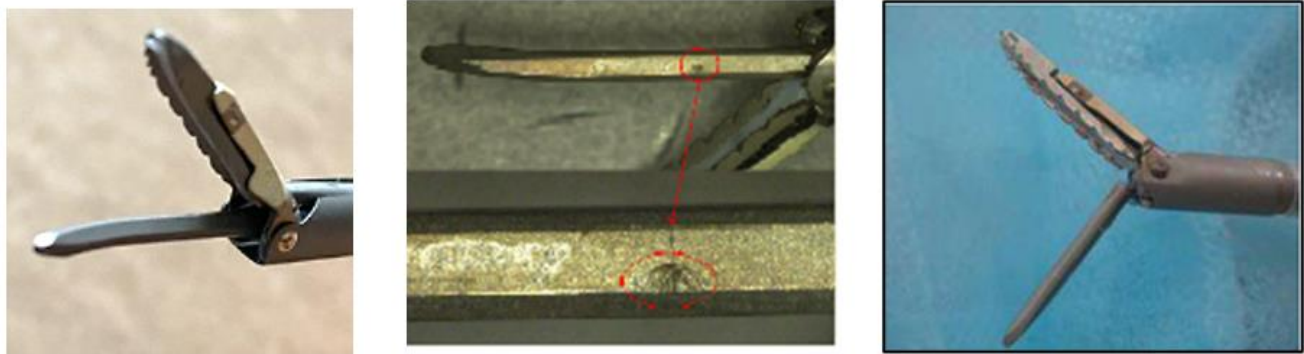
- **Probe tip damage or breakage** - Multiple instances where probe tips of THUNDERBEAT™ Type S hand instruments have become damaged or broken during use (reference example in Figure 1).
- **Tissue pad issues** - Reports of tissue pad damage or detachment from the instruments (reference example in Figure 2).

Olympus was made aware, via customer complaints, of reports where probe tips of THUNDERBEAT™ hand instruments are becoming damaged or are breaking (reference example in Figure 1), as well as instances of tissue pad damage or detachment (reference example in Figure 2). Investigations by Olympus demonstrated that these issues can occur when the instructions and warnings in the IFU are not followed, specifically, taking very large bites of tissue, contact with metal while activating, and activation without tissue between the jaws. However, due to a continuation of occurrences of this issue, Olympus is removing potentially affected models of THUNDERBEAT™ hand instruments from the market.

Figure 1. Example of Thunderbeat Probe in accordance with specifications (left), Cracked Probe (Center) and Probe Fracture (right)

1. Examine your inventory for affected Thunderbeat hand instrument models as listed on page 1 of this FSN.
2. **Immediately cease use of all affected devices and quarantine the products.**
3. If you have affected products in your inventory, please contact Olympus with regard to return of affected products. Olympus will issue a credit to your facility upon return of your affected product.
4. Olympus requests that you acknowledge receipt of this FSN.
5. If you have further distributed THUNDERBEAT™ devices, please identify your customers and forward this notice to them immediately.

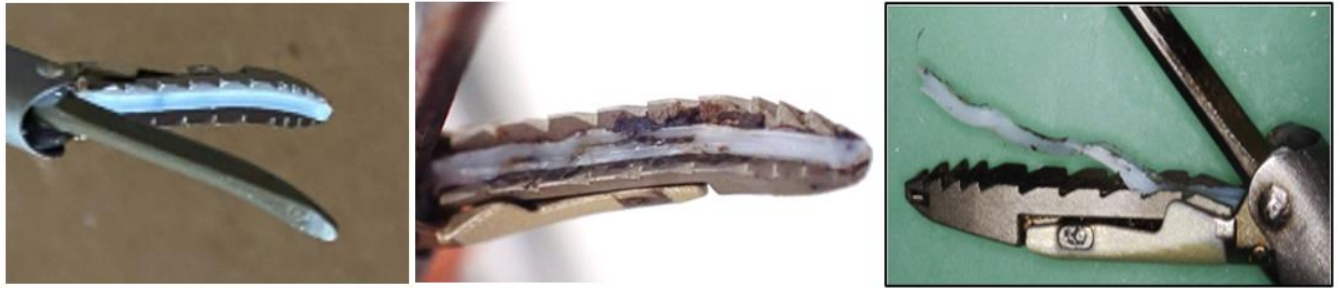
Figure 2. Example of Thunderbeat Probe in accordance with specifications (Left), Tissue Pad Deformation (Center), Tissue Pad Detachment (Right)
