Olympus reference: QIL FY26-EMEA-17-FY25-009-A Thunderbeat Probe Fracture and Tissue Pad Detachment

## URGENT FIELD SAFETY NOTICE

RE: THUNDERBEAT™ Hand Instrument

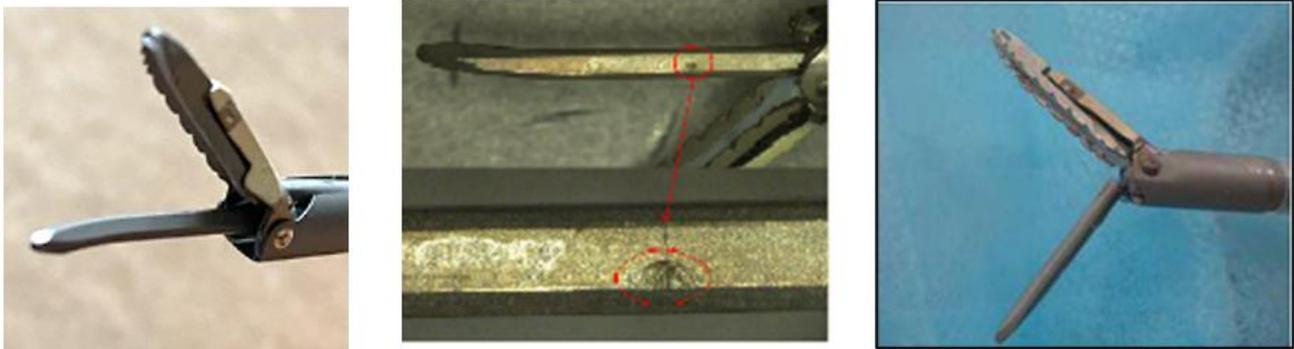
- **Probe tip damage or breakage** - Multiple instances where probe tips of THUNDERBEAT™ Type S hand instruments have become damaged or broken during use (reference example in Figure 1).

Olympus was made aware, via customer complaints, of reports where probe tips of THUNDERBEAT™ hand instruments are becoming damaged or are breaking (reference example in Figure 1), as well as instances of tissue pad damage or detachment (reference example in Figure 2). Investigations by Olympus demonstrated that these issues can occur when the instructions and warnings in the IFU are not followed, specifically, taking very large bites of tissue, contact with metal while activating, and activation without tissue between the jaws. However, due to a continuation of occurrences of this issue, Olympus is removing potentially affected models of THUNDERBEAT™ hand instruments from the market.

*Figure 1. Example of Thunderbeat Probe in accordance with specifications (left), Cracked Probe (Center) and Probe Fracture (right)*

A broken probe tip or a damaged tissue pad may lead to various patient harms. Of these harms, the most common harm is a foreign body in the patient due to a probe tip and/or tissue pad that becomes damaged and breaks off the device during use. When this occurs, this can also potentially result in a prolonged operative time, the requirement to perform imaging examinations, or an additional surgical procedure to locate and remove the broken device fragment. In rare circumstances, tissue damage could occur due to exposed sharp edges on the device when the probe tip breaks or becomes damaged. Additionally, bleeding may occur if the tissue pad fails or probe breaks, causing an inadequate seal. Post-operative bleeding events could, in rare circumstances, result in life-threatening injuries. Olympus has received one complaint of a postoperative death due to hemorrhage; however, the device was not returned to Olympus for further evaluation and there was insufficient information in the reported complaint details provided to Olympus to conclude the hemorrhage was causally related to probe tip or tissue pad damage.

1. Examine your inventory for affected Thunderbeat hand instrument models as listed on page 1 of this FSN.
2. **Immediately cease use of all affected devices and quarantine the products.**
3. If you have affected products in your inventory, please contact Olympus with regard to return of affected products. Olympus will issue a credit to your facility upon return of your affected product
4. Olympus requests that you acknowledge receipt of this FSN.
5. If you have further distributed THUNDERBEAT™ devices, please identify your customers and forward this notice to them immediately.

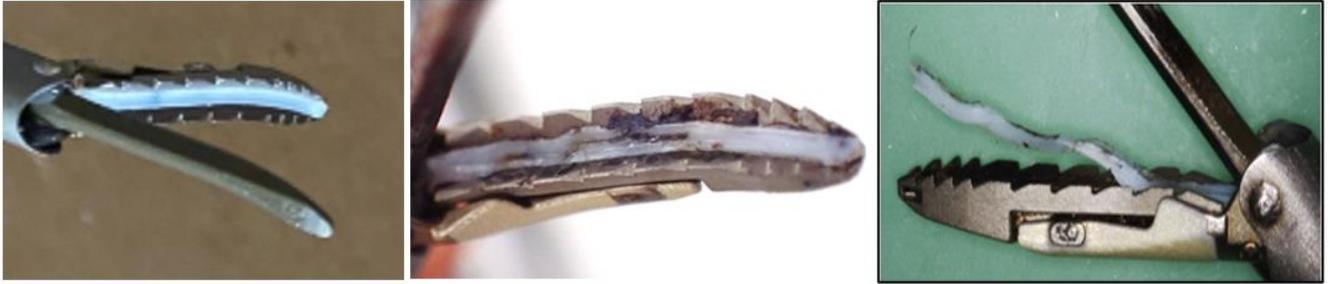
- **Tissue pad issues** - Reports of tissue pad damage or detachment from the instruments (reference example in Figure 2).

Figure 2. Example of Thunderbeat Probe in accordance with specifications (Left), Tissue Pad Deformation (Center), Tissue Pad Detachment (Right)

The potential harms of burn(s), granuloma, and inflammatory reaction may also result due to a broken probe tip or tissue pad that is not immediately retrieved and/or is unretrievable. While not seen in the complaint data, these harms may occur on rare occasions. The potential harm of burn(s) may occur due to retained heat in the probe tip or tissue pad that potentially breaks off into a patient.
