Olympus Reference: QIL FY26-EMEA-14-FY26-903-F KD-645L & KD-640L

URGENT FIELD SAFETY NOTICE

RE: Triangle Tip Knife J – Single Use Electrosurgical Knives

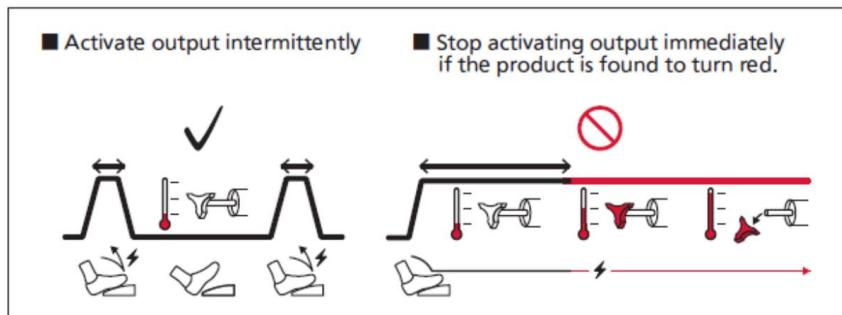
Olympus' investigation, after receiving complaints about the triangle tip of the KD-640L and KD-645L Triangle Tip Electrosurgical Knives breaking off during use, determined that deterioration of the cutting knife, caused by overheating and burning, can contribute to tip breakage during use.

Per the Warnings in the IFU (listed below), users should only activate the device output intermittently and should stop activating the output immediately if the device's triangle tip turns red.

- Addition of the following **visual aid** to more clearly communicate these instructions to users.
