Field Safety Notice - Single Use Cold Snare

Company Name: Transmed (China) Co., Ltd.

1.1 Device Name: Single Use Cold Snare

1.2 Trade Name: ScopeSnare Cold

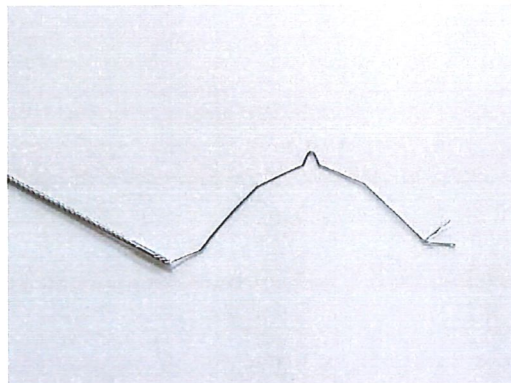
Figure 1: Schematic Diagram of Unilateral Snare Loop Detachment

During endoscopic polypectomy with the Single Use Cold Snare, there is a potential risk of unilateral or complete detachment of the snare loop.

Failure scenario: One side of the wire is still connected inside the connecting tube, while the other side has detached, as shown in Figure 1.

Core principles: Upon the detachment is discovered, immediately stop any snaring or tightening action, keep the instrument fixed in place; do not advance, withdraw, or rotate arbitrarily, to prevent the free sharp wire end from scratching or piercing tissue.

In such scenario, please immediately stop using the snare; do not attempt to continue snaring or resection.

- 1) When detachment occurs, slowly and gently retract the handle under the endoscopic view, and try to withdraw the wire completely back into the outer sheath of the snare.
- 2) If the loop diameter is too large to be retracted into the outer sheath, tighten the handle and then slowly pull back the snare, so that the exposed wire retracts into the endoscope.
- 3) Replace with a new device to complete the procedure.

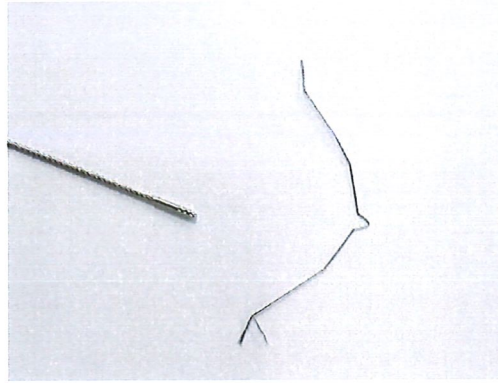
Figure 2: Schematic Diagram of Complete Snare Loop Detachment

Failure scenario: The snare loop has completely detached inside the body, as shown in Figure 2.

Regarding the clinical loop detachment issue of Single-Use Cold Snare, the possible cause may be that during the procedure, the polyp being removed was too large, or under other extreme operating conditions, the product was required to withstand greater tensile forces.

In such scenario, please follow the endoscopic retrieval method below to avoid injury.

- 1) Position the endoscope tip as close as possible to the wire. Use a grasping forcep to grasp the wire near the endoscope tip, then slowly withdraw the forcep to pull the wire into the endoscopic channel. Then withdraw both the endoscope and the forcep. See Figure 3 for the simulation illustration.
- 2) If the loop detachment occurs in a large space such as the stomach, first lift the wire away from the mucosa (suspended), then retrieve it using the above method.
- 3) Replace with a new device to complete the procedure.
