## **Urgent Field Safety Notice**

For defibrillation electrodes:

50116 - REF DF28N SKINTACT DF28N Adult

50518: REF DF30G SKINTACT DF30G Pediatric

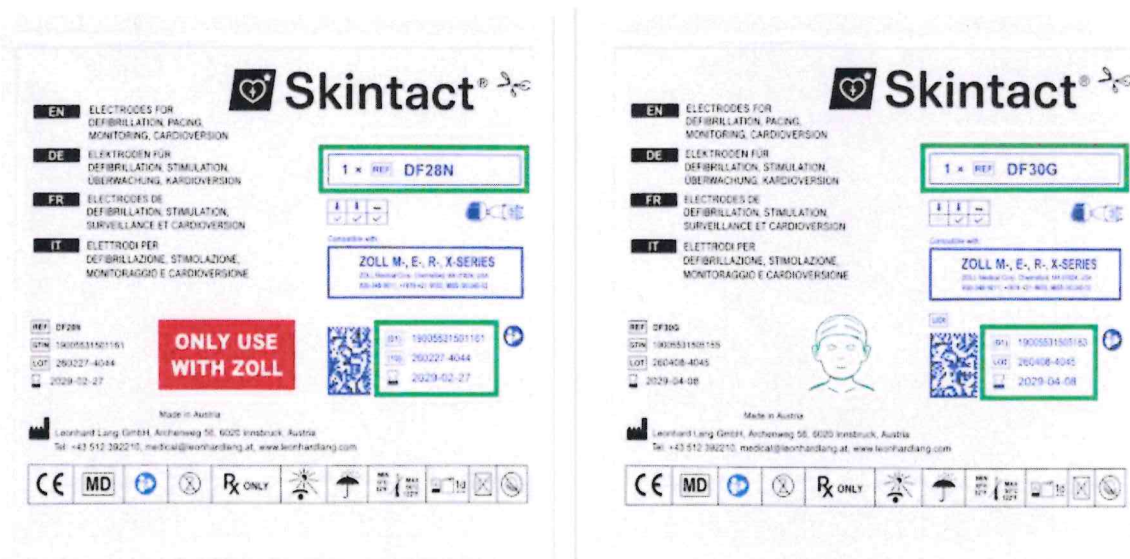
Figure 1 Identification of potentially affected product based on REF, Lot number and expiry date on the label.

| 1. Information on Affected Devices* | |
|---|---|
| | REF DF28N: 250722-4045, 260227-4044, 260319-5482, 260430-5489, 260528-5484<br>REF DF30G: 260202-4047, 260408-4045 |

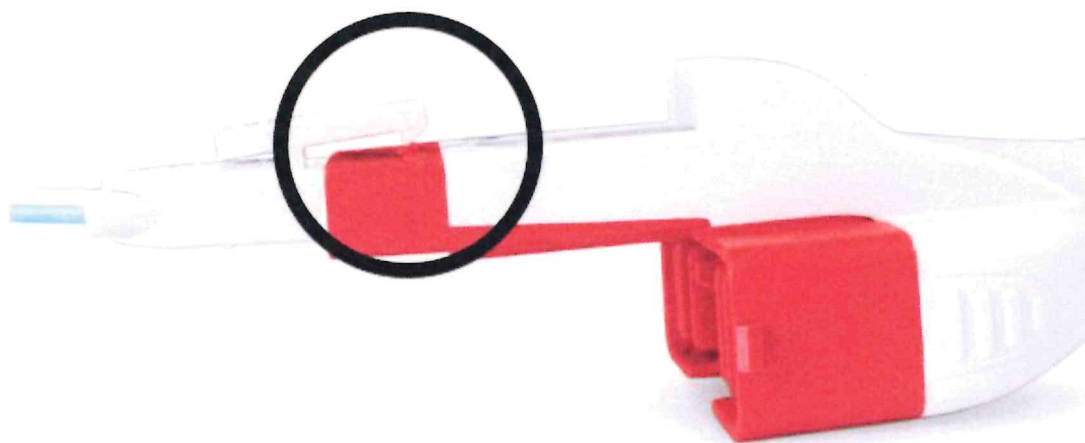
| 2. Reason for Field Safety Corrective Action (FSCA)* | |
|---|---|
| 2. | <b>1. Description of the product problem*</b><br>The connector cannot be fully inserted into the compatible adapter cable using the usual amount of force. The locking tab does not engage and the audible "click" is absent (see Figure 2). |
| 2. | <b>2. Hazard giving rise to the FSCA*</b><br>Electrical contact and retention force meet the requirements; safety and performance are not impaired, and intended use remains possible. However, the locking tab not engaging may confuse users and delay treatment. |
| 2. | <b>6. Background on Issue</b><br>Error in the connector manufacturing process. |

Figure 2. Locking mechanism that does not fully engage

| 3. Type of Action to mitigate the risk* | |
|---|---|
| 3. | <b>1. Action To Be Taken by the User*</b><br>Electrodes can be used without restrictions. |

| 3. | <b>3. Action Being Taken by the Manufacturer*</b><br>Correction of the manufacturing process and implementation of a reliable detection method (100% inspection) for this deviation. | |
