Date: 12.09.2024

Urgent Field Safety Notice

IPPB Flextube™ breathing system

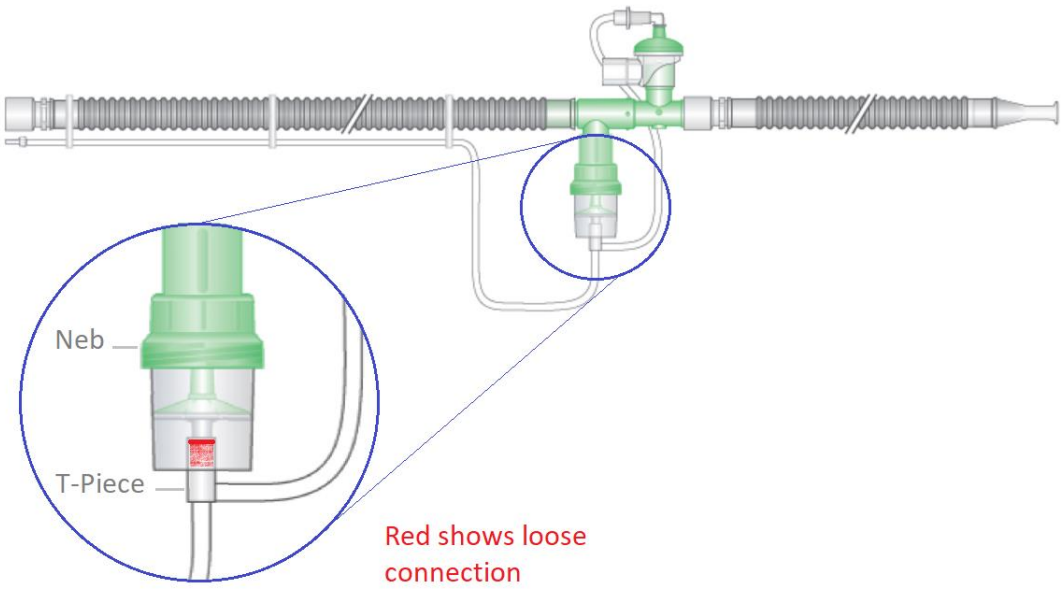
1. We have received a report of loose connections between the nebuliser and supply line T-Piece in one of our IPPB breathing systems (see figure1 below). When the system is pressurised, there is the possibility that the T-Piece can detach from the nebuliser.
See Actions 1. and 2. in Sec. 3.1 below.

***Figure 1**: IPPB Breathing system schematic showing zoom detail of nebuliser and supply line T-Piece connection*

The disconnection of the nebuliser/ exhalation valve control T-Piece during use would cause a minor delay or interruption of treatment.

2. The security of connection between the Nebuliser and T-Piece can be checked by hand through the packaging. Secure connection should be possible using the push and twist action as detailed in the device Instructions For Use.

Please isolate any products you identify with loose connections, and return them to us.

Additionally to the current instructions for use, you must confirm a secure connection can be achieved between the nebuliser and gas supply, using a push and twist action. This new instruction is currently being added to the IFU for the future.

3. If a secure connection cannot be achieved with a device, remove from use, quarantine the product and please return to us immediately.
