DATE: 10th November 2026

FSCA/FSN REF.: MDS-26-06177

URGENT: FIELD SAFETY NOTICE (FSN)
BD Connecta™ Stopcock

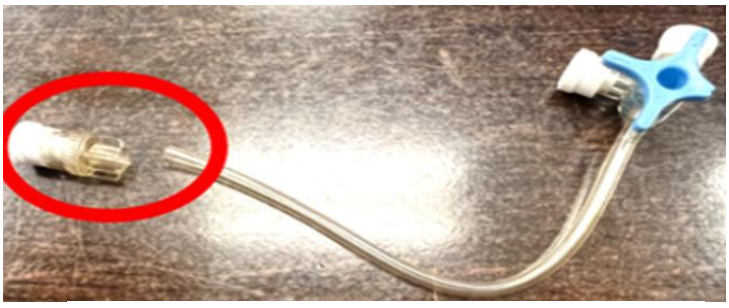
Based on customer feedback, BD has identified that specific lot numbers of the BD Connecta™ Stopcock product codes listed above (refer to the webpage to identify the affected lot numbers) may have been manufactured with an inadequate amount of solvent and may result in separation of the tubing from the male luer component, refer to image 1.

Image 1: Location of tubing to luer separation

Separation of the Connecta™ Stopcock extension tubing may occur during use, resulting in a compromised fluid pathway. This may result in leakage with the potential consequences including under-infusion or disruption of prescribed therapy, exposure to potentially hazardous fluids, infection or air embolism. The separation may be apparent upon initiation of infusion, or during standard patient care at which point the healthcare professional can promptly discontinue use and replace the affected stopcock extension set.

- Cease use of the Affected Product listed above.
  - The Affected product codes and lot numbers can also be found on the webpage: https://bdx.my.site.com/CC360/s/impactedproducts?language=en_US&rn=MMS-26-06177%20GLOBAL
- If the product is currently in use, replace immediately with unaffected product.
  - If the product is already in use and you are unable to determine if it is within scope as the packaging or other records are not available, it is recommended to replace with unaffected product.
- If affected product has already been used and is no longer in situ, no patient follow up activities are required.
