URGENT – FIELD SAFETY NOTICE

Arjo Sara Plus lift – Risk of ignition

Date:	31 March 2022
Product Issue:	Risk of device ignition
Affected Product:	Sara Plus floor lifts
Resolution:	Product retrofit by Arjo service
Field Safety Notice:	FSN-POZ-001-2022
Pages:	5
Single registration number of manufacturer in EU:	SE-MF-000000696

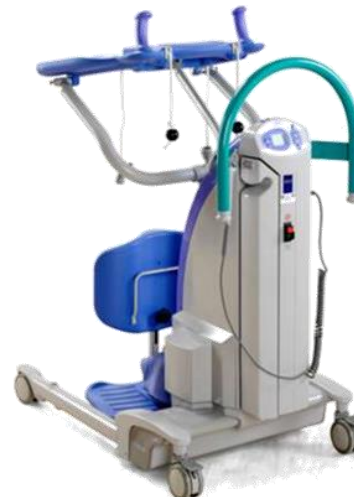
Our sales and service records indicate that you may be in possession of one or more Sara Plus lifts equipped with a PCB (Printed Circuit Board) that is prone to damage during product use. The PCB is an electronic part located inside the lift underneath the cover, as shown below.

It has been found that internal damage of the affected HMX1350-1 PCB may lead to overheating of the part and excessive heat emission which could potentially damage the PCB cover or, in the worst case, cause its ignition.

We are notifying you of a required corrective action on affected devices.
