<b>URGENT: VOLUNTARY FIELD SAFETY NOTICE</b>	
<b>Description</b>	<b>Handling guidance for specific catalog numbers of Alcon Phaco Tips when used with included plastic wrench</b>
<b>Relevant Product</b>	<b>Alcon Phaco Tips</b> (see Attachment 1)
<b>Alcon Record ID</b>	<b>2023.011</b>

5<sup>th</sup> July 2023

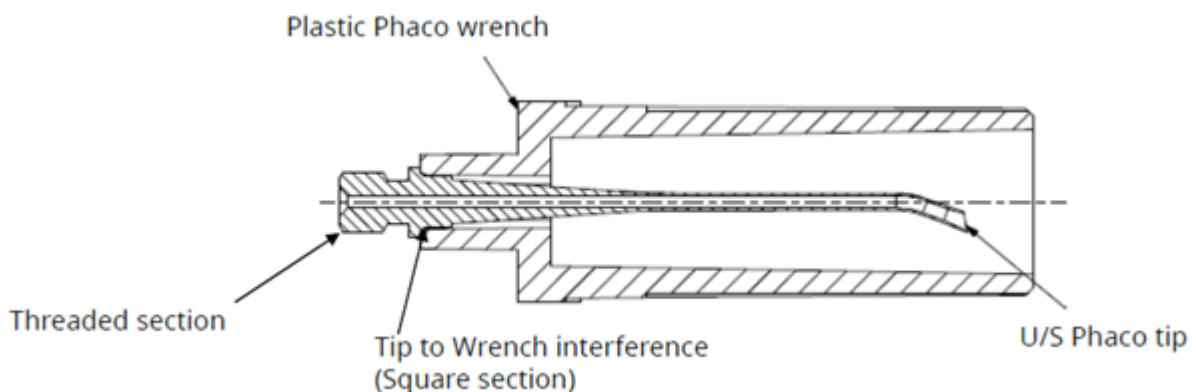
Alcon has become aware of the potential for the Phaco Tip wrench to generate plastic shaving particles if the Phaco Tip is over-tightened to the handpiece to the point where the wrench slips over the tip-to-wrench interface.

Please review the following information regarding specific catalog numbers of Alcon Phaco Tips and packs or kits containing those Phaco Tips. The purpose of this letter is to provide you with additional guidance on handling of the plastic wrench when tightening the Phaco Tip to mitigate the risk of generating plastic particles.
