Urgent Field Safety Notice

VARIOUS MAPLESON F ANAESTHETIC BREATHING SYSTEMS CONTAINING 0.5L RESERVOIR BAGS WITH OPEN TAILS

FSN Ref: 446776 FSCA Ref: 446775

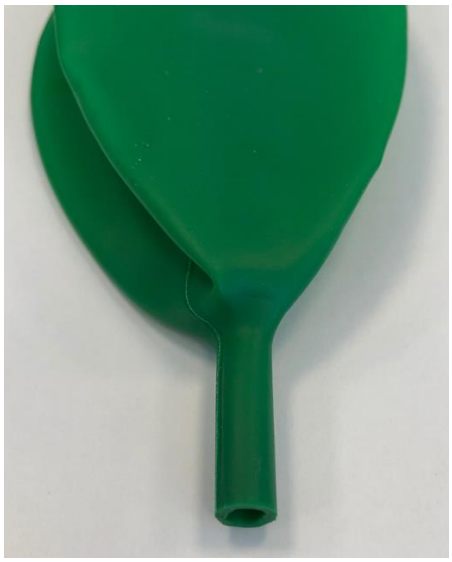
2. Reason for Field Safety Corrective Action (FSCA)*
2.	1. Description of the product problem*
	Some devices contain a reservoir bag with a closed tail, when they should have a reservoir bag with open tail.

**Correct – Open Tail Reservoir Bag** **Incorrect – Closed Tail Reservoir Bag**

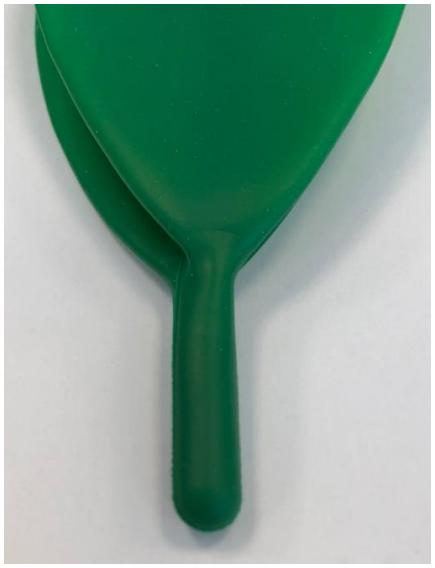
2.	2. Hazard giving rise to the FSCA*
	If the incorrect closed tail reservoir bag is not identified during the routine pre use check as described in the product instruction for use, it could result in over pressurisation of the system leading to potential barotrauma.

We have implemented corrective actions in manufacturing process to eliminate this problem for future supply. We will also be introducing a new instruction for use which will include the following Pre-Use Check in line with the recommended action 2. above: *If the product is supplied without an APL valve, the pressure within the system is controlled by the clinician through manipulation of the open tail on the reservoir bag. Check that a patent gas pathway exists through the open tail of the reservoir bag.*		
3	6. By when should the action be completed?	One month from receipt of the FSN	
3.	7. Is the FSN required to be communicated to the patient /lay user?		No
3	8. If yes, has manufacturer provided additional information suitable for the patient/lay user in a patient/lay or non-professional user information letter/sheet?		
	N/A
