URGENT Field Safety Notification

FSCA 2022-10

Specific attention to details in the Instruction for Use of TRACOE Tracheostomy Tubes:

TRACOE *vario* P-Tracheostomy Tube, TRACOE *experc Set vario*,

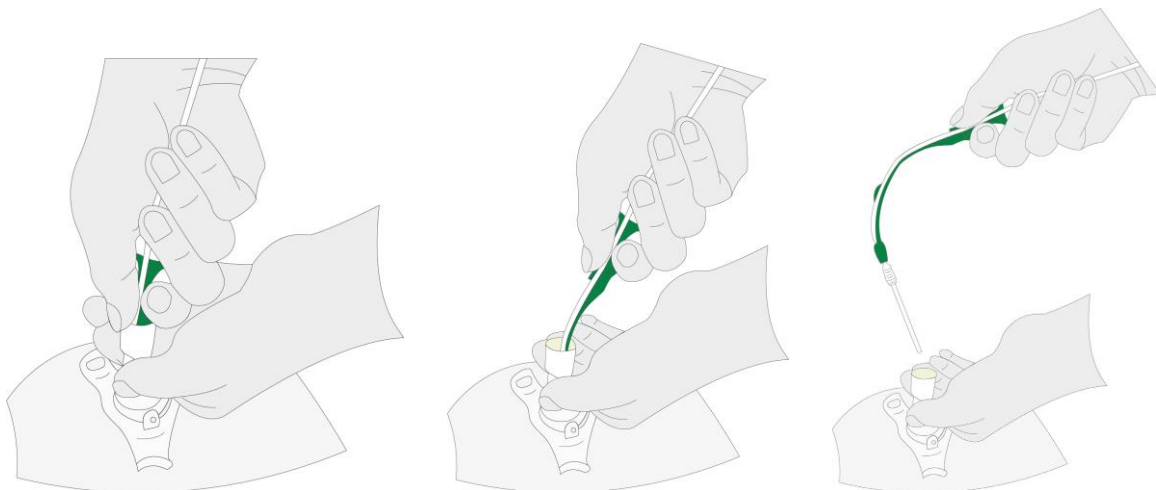
Pic. Correct pulling out the inserter / insertion system together with the guiding catheter for TRACOE *twist plus*

- Apply a pea-sized amount of the enclosed **lubricating gel** on the tip of the inserter / insertion system and the tracheostomy tube.
- Do not pull on the guiding catheter separately while the inserter is still inside the tube. **Pull out the inserter / insertion system always together with the guiding catheter and Seldinger wire** or remove the inserter first before pulling on the guiding catheter leaving the tracheostomy tube in place in the trachea.
- Ensure that the silicone sleeve is still on the guiding catheter when the guiding catheter is pulled out.

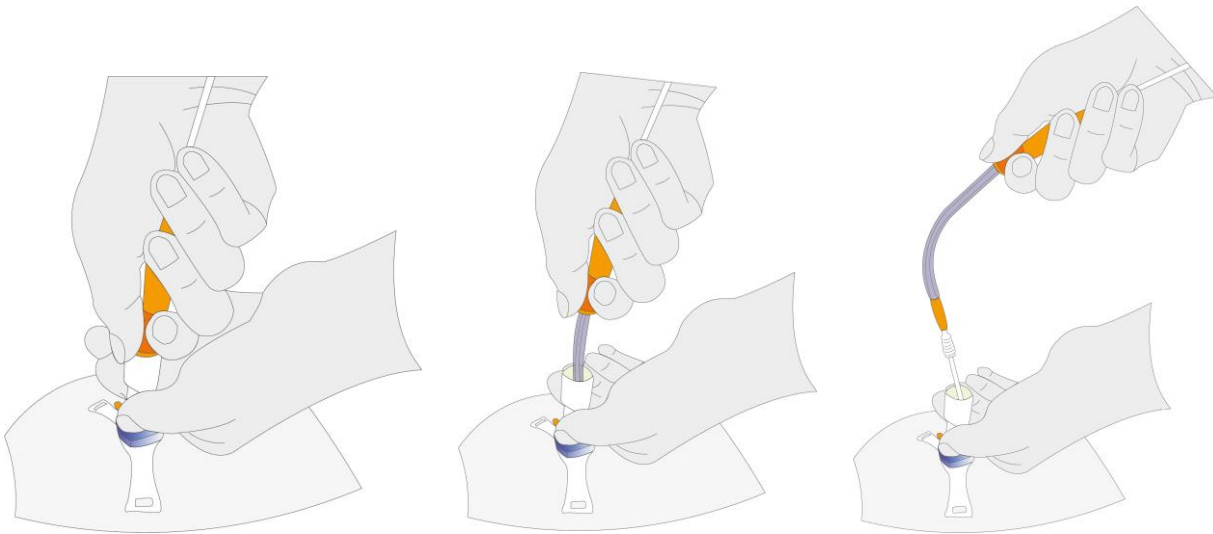
Pic. Correct pulling out the inserter / insertion system together with the guiding catheter for TRACOE vario
