**URGENT FIELD SAFETY NOTICE**

GE HealthCare Ref. # 39004

RE: **TruSignal SpO2 Sensors – potential reduction of energy reaching patient during defibrillation, potential contact with unintended voltage, or inaccurate measurement**

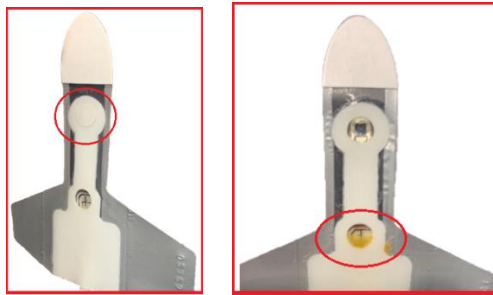
Affected TruSignal Adult/Pediatric SpO2 Sensors (see Table 1 below) may contain additional material that can block the emitter or detector areas potentially leading to an inaccurate SpO2 reading, which could contribute to an adverse patient outcome.

**Figure 1: Defective TruSignal Adult/Pediatric Sensor with material blocking emitters and detectors.**

1. Before using Adult/Pediatric SpO2 Sensors (see Table 1), confirm that the sensor does not contain additional material covering the emitter or detector (See Figure 1).
2. If any additional material is present, discard the sensor and select another sensor. (An image of a non-impacted TruSignal SpO2 Sensor is shown in Figure 2.)

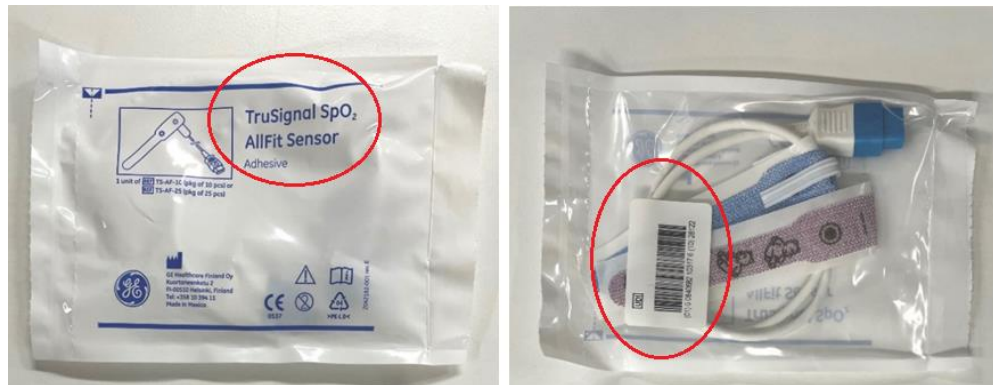
For disposable sensors, the product name, model number and GTIN are located on the product packaging as shown in Figure 3.

**Figure 3:** REF/Catalog number, product name & GTIN on Disposable Sensors pouch

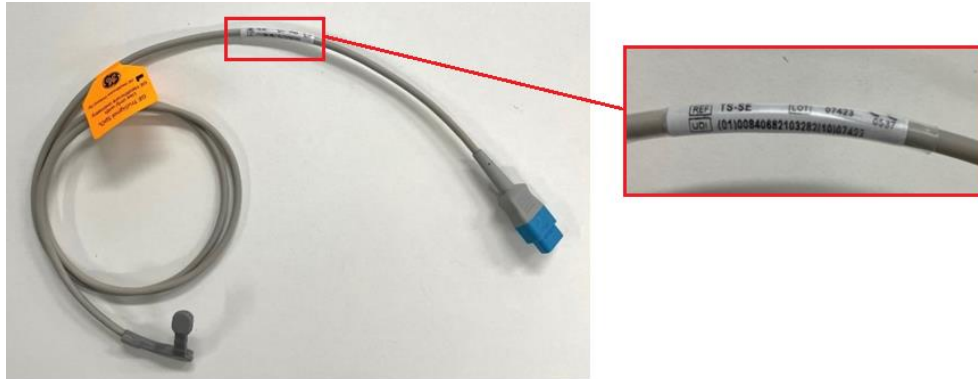
For reusable sensors, if the packaging is not available, the product name, model number and GTIN can be found on the product itself as shown in Figure 4.

**Figure 4:** REF/Catalog number & GTIN on Reusable Sensors wrap label closer to blue connector

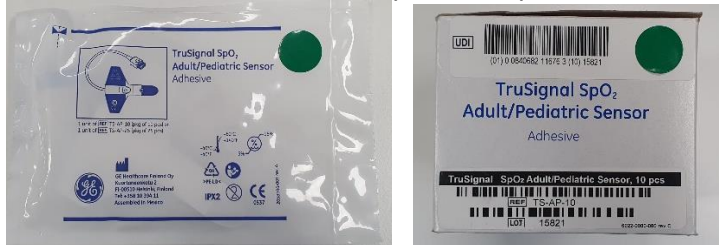
If you receive any of the devices listed in Table 1 marked with a green circle on the packaging (See Figure 5), these have been inspected by GE HealthCare in manufacturing and are not affected by the 3 issues in this correction.

**Figure 5:** Identification of non-impacted Disposable sensors

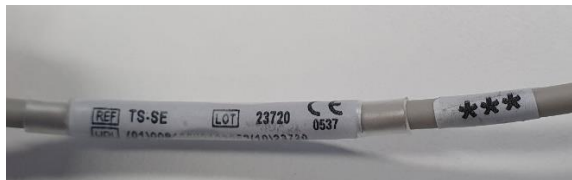
In addition to the green circle on their packaging, reusable sensors will also include an additional wrap label with three asterisks (\*\*\*) next to the GTIN label (See Figure 6). This means that they were inspected by GE HealthCare in manufacturing and are not impacted by the 3 issues in this correction.

**Figure 6:** Identification of non-impacted Reusable sensors
