Urgent Field Safety Notice

New warning in Instructions for Use for Ambu® aView™ 2 Advance

Ambu A/S - Single Registration (SRN): DK-MF-000001437

27.11.2023

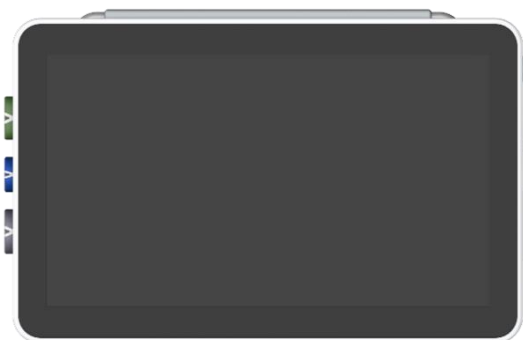
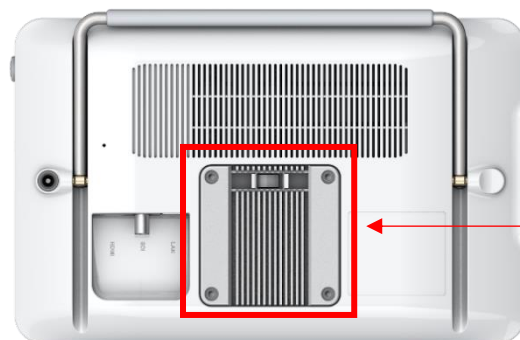
← VESA interface for mounting on medical carts

Ambu has received information on two incidents where Ambu® aView™ 2 Advance caught fire when mounted on the VESA holder of the aCart™ Compact, due to the screws used entering the lithium-ion battery of the device. No patients or staff members were harmed during the incidents.

Upon conducting a comprehensive investigation, we have identified the root cause of these incidents. The fire hazard was a direct consequence of a battery short-circuit, which, in turn, was triggered by the use of excessively long screws to secure the device on the VESA holder. The longer screw lengths inadvertently penetrated the lithium-ion battery, leading to the fire hazard.

Use only M4 screws with the length of 14 – 16 mm when mounting Ambu aView 2 Advance on a VESA interface. Using longer screw lengths will penetrate the lithium-ion battery and result in a fire hazard and battery leakage which can cause severe burns, smoke inhalation and skin irritation. Using shorter screw lengths could result in unsecure device fastening.
