Urgent Field Safety Notice

New warning in Instructions for Use for Ambu® aView™ 2 Advance

Ambu A/S - Single Registration (SRN): DK-MF-000001437

27.11.2023

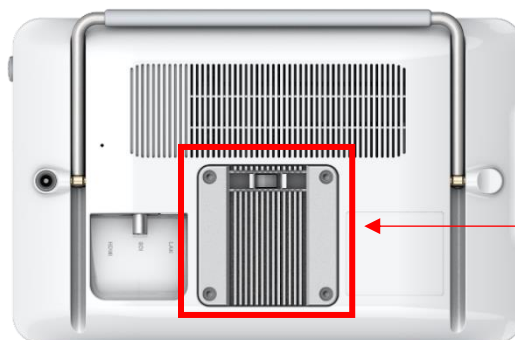
← VESA interface for mounting on medical carts

Ambu has received information on two incidents where Ambu® aView™ 2 Advance caught fire when mounted on the VESA holder of the aCart™ Compact, due to the screws used entering the lithium-ion battery of the device. No patients or staff members were harmed during the incidents.

Upon conducting a comprehensive investigation, we have identified the root cause of these incidents. The fire hazard was a direct consequence of a battery short-circuit, which, in turn, was triggered by the use of excessively long screws to secure the device on the VESA holder. The longer screw lengths inadvertently penetrated the lithium-ion battery, leading to the fire hazard.

Use only M4 screws with the length of 14 – 16 mm when mounting Ambu aView 2 Advance on a VESA interface. Using longer screw lengths will penetrate the lithium-ion battery and result in a fire hazard and battery leakage which can cause severe burns, smoke inhalation and skin irritation. Using shorter screw lengths could result in unsecure device fastening.
